Managing Water Quality in Urban Lakes and Wetlands

Wetland Management and Restoration

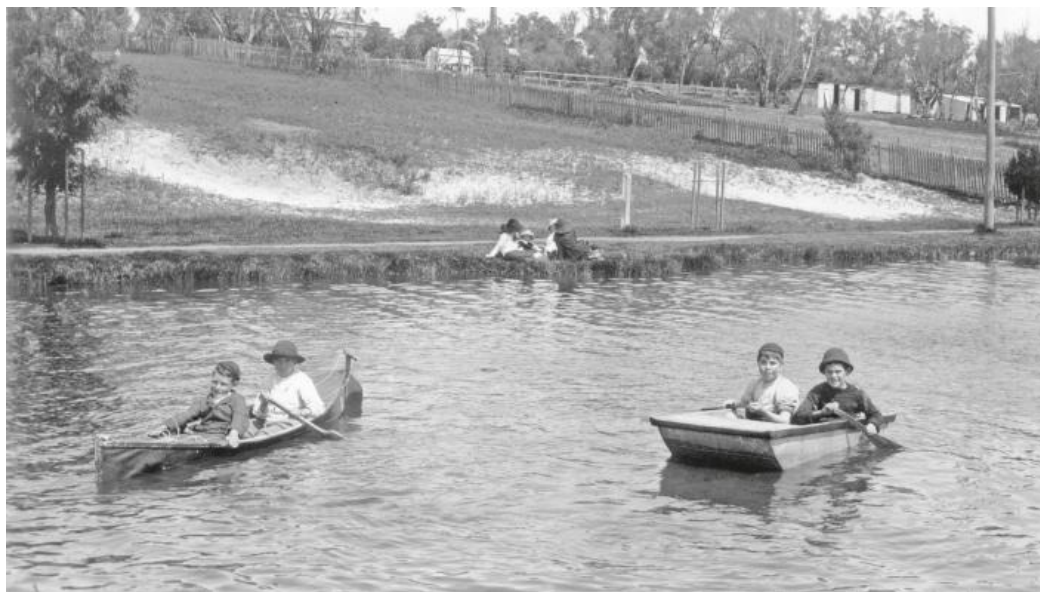
- Lake Monger c1912

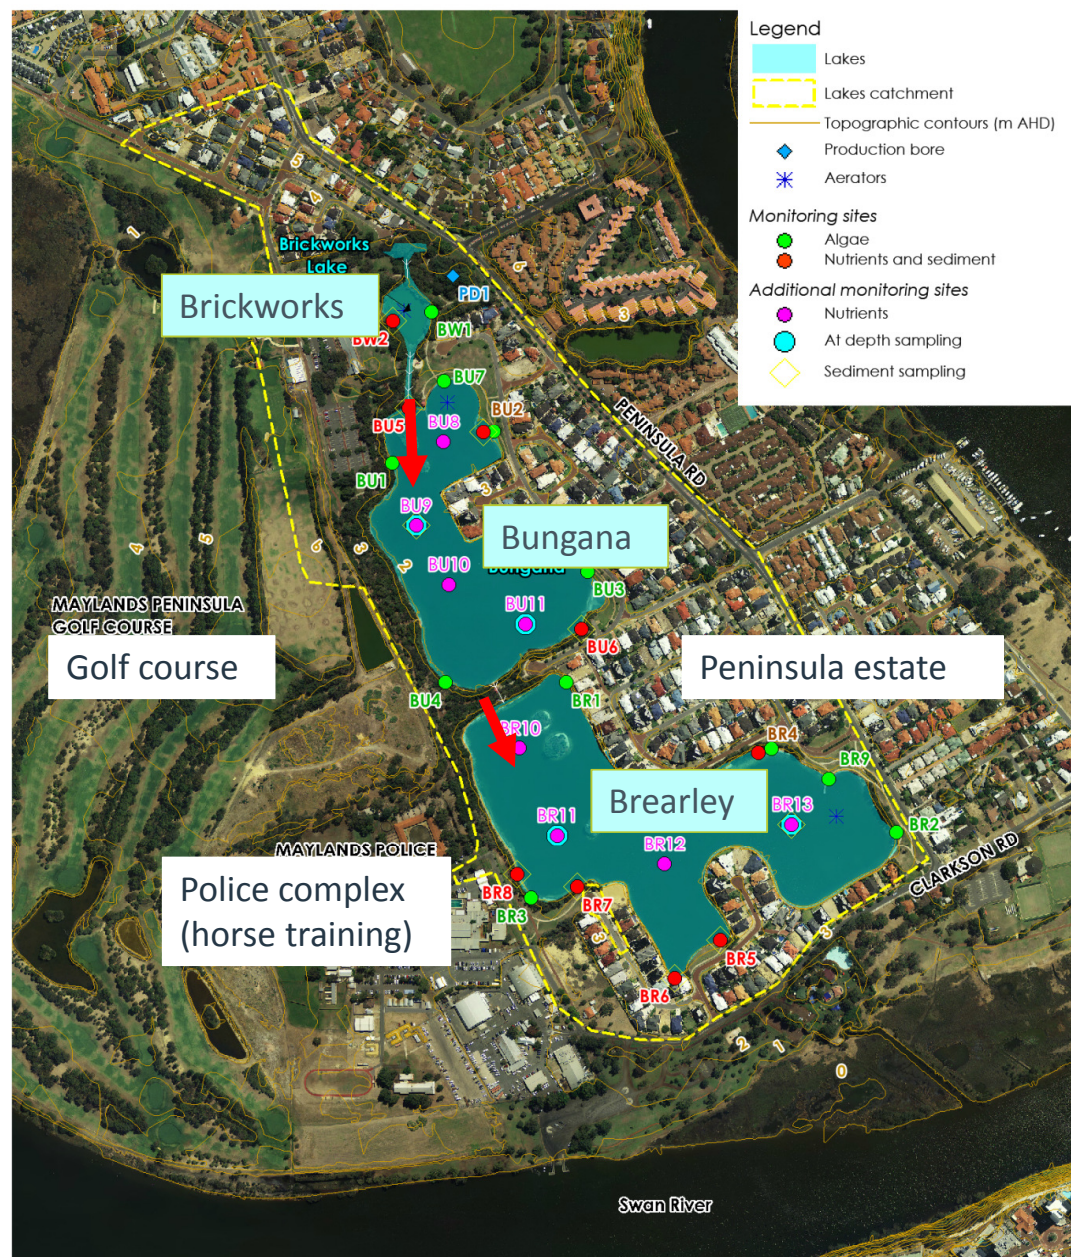
Case study – Maylands Lakes

- Historical site of Maylands Brickworks clay pits
- Now three hydraulically connected lakes
- Former clay pits allowed to fill naturally with groundwater seepage
- Brickworks fed with groundwater
- Stormwater discharges to all three

Case study – Maylands Lakes

- What did the data tell us?
 - Nitrogen frequently above guidelines in the water column
 - Phosphorous rarely above guidelines in the water column
 - Strong correlation between seasonal rainfall & nutrient concentrations
 - High levels of nutrients present in sediment
- So what causes the algal blooms?
 - Groundwater? – **not likely** considering relatively good quality of Brickworks Lake
 - Stormwater runoff? – **likely** given numerous direct discharges & seasonal correlation
 - Management practices? – **likely** given evidence of floating grass clippings (also; fertiliser, rubbish)
 - Sediment? – **likely** build-up over time since establishment including dead algae, grass clippings, guano, and rubbish

- Maylands Lakes
 - Phoslok application
 - Revegetation of suitable riparian areas
 - Floating wetlands
 - Modification of lake shape
 - Dredging
 - Community education
 - Gross pollutant traps (later added at request of community)
- Gosnells Lakes
 - Monitoring & maintenance changes
 - Management trials including some of the above

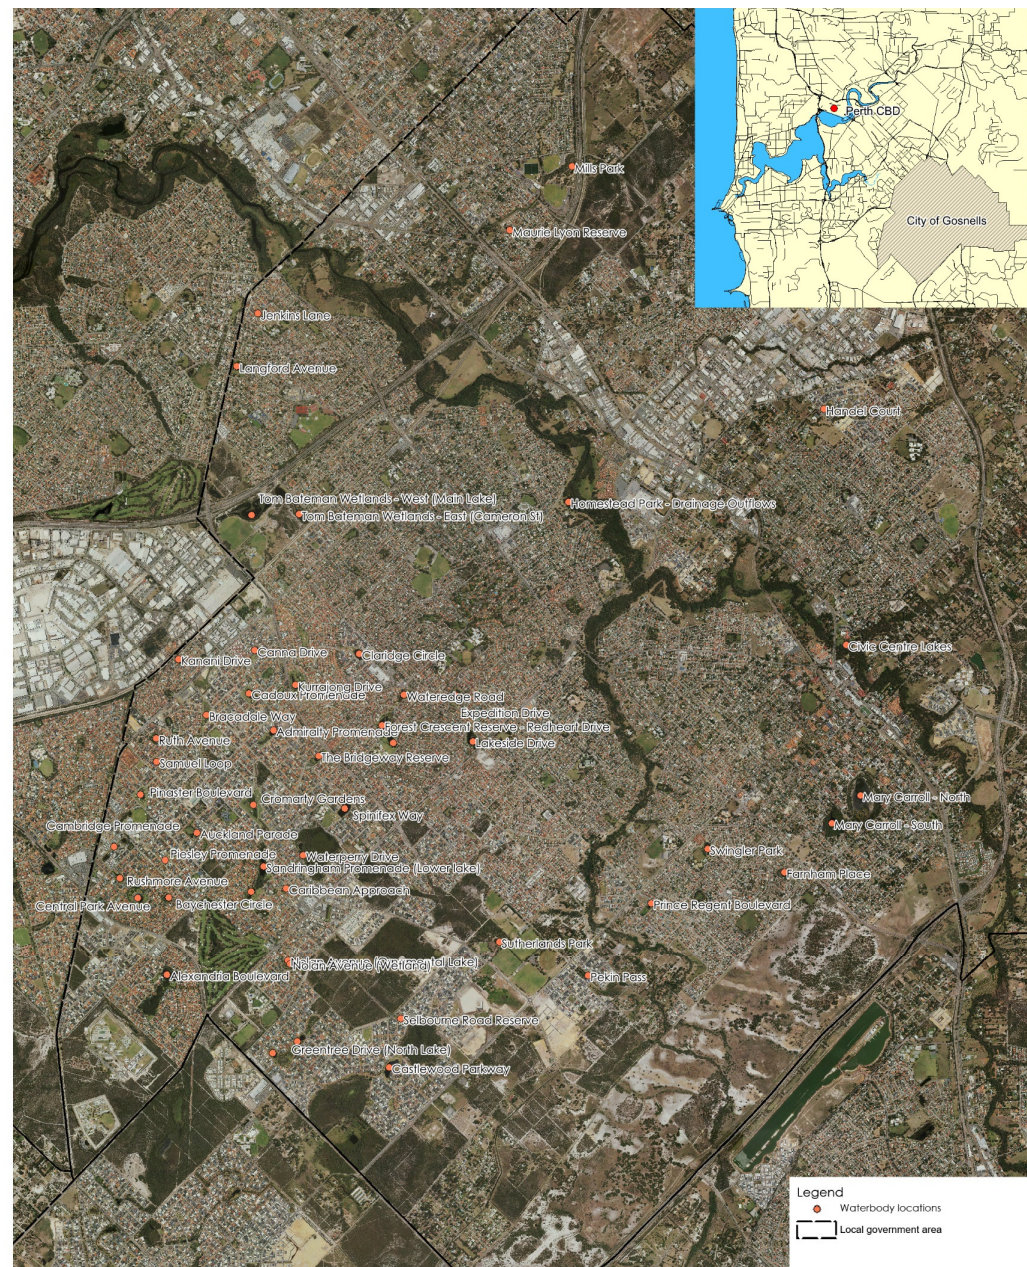
Case Study – Gosnells Lakes

- 54 water bodies:
 - Lined/unlined
 - Stormwater and/or groundwater fed

Case Study – Gosnells Lakes

- What did the data tell us?
 - Mix of issues including:
 - Algal blooms
 - Botulism
 - Mosquitoes
 - Poor hydraulics
 - Litter/silt and other aesthetic issues
 - Algal blooms more prevalent when lakes are unlined and/or topped up with groundwater
 - WQ sampling needs to be supported by well timed maintenance and good general record keeping to obtain its full value

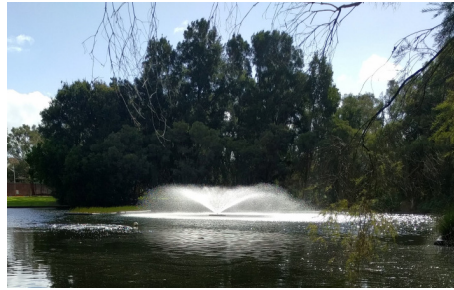
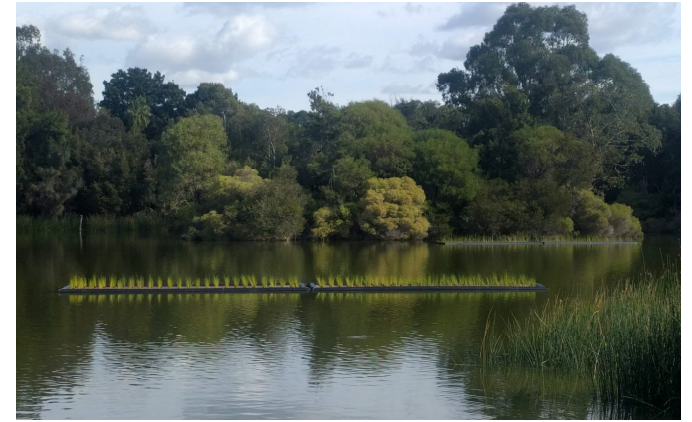
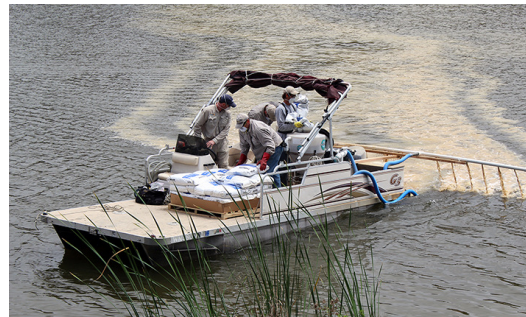
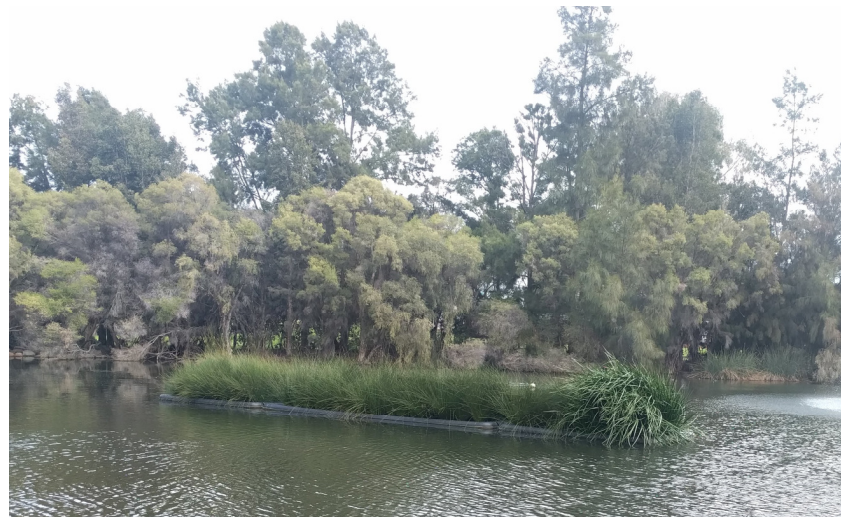
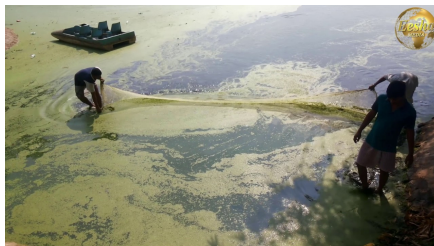
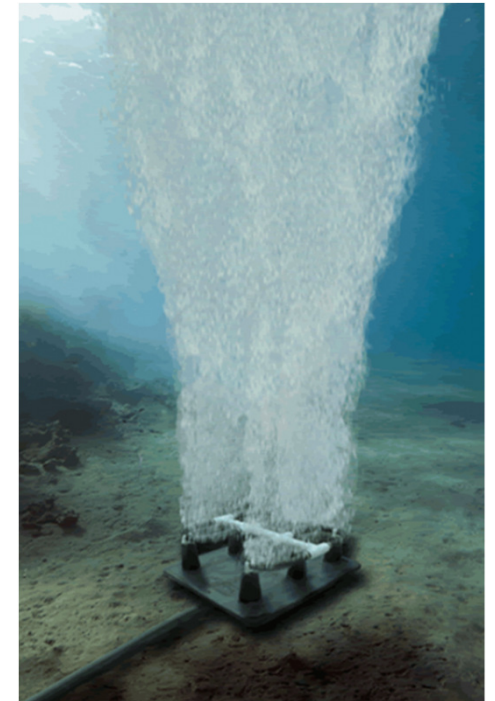
Treatment

- Phosphorous inactivation
- Algicide
- Bioaugmentation
- Floating wetlands
- Aeration
- Physical removal

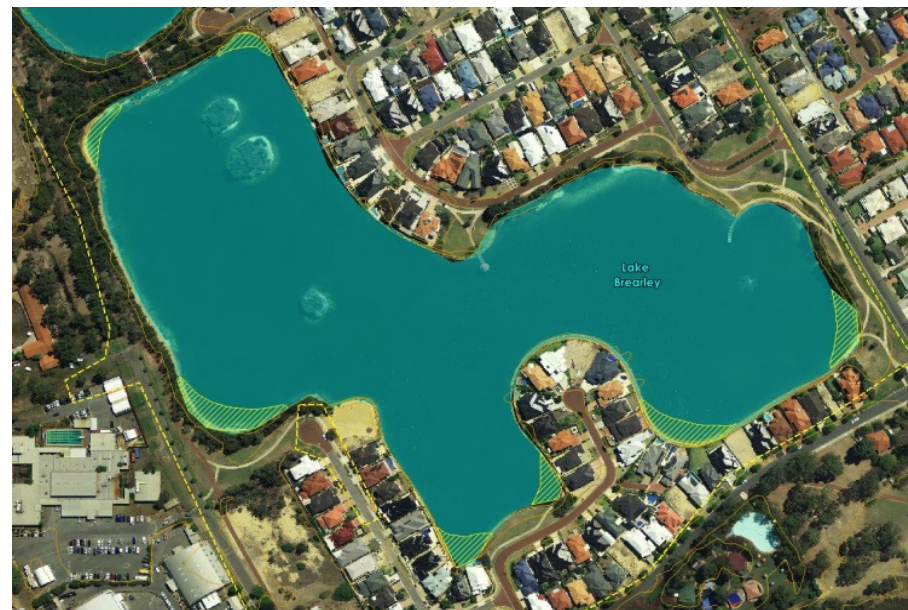
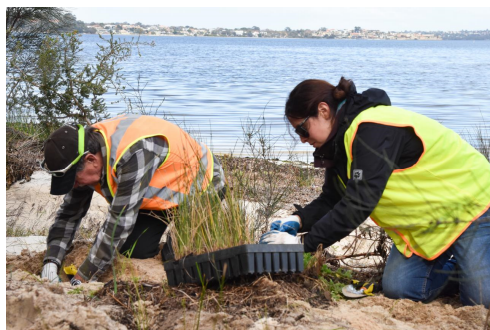
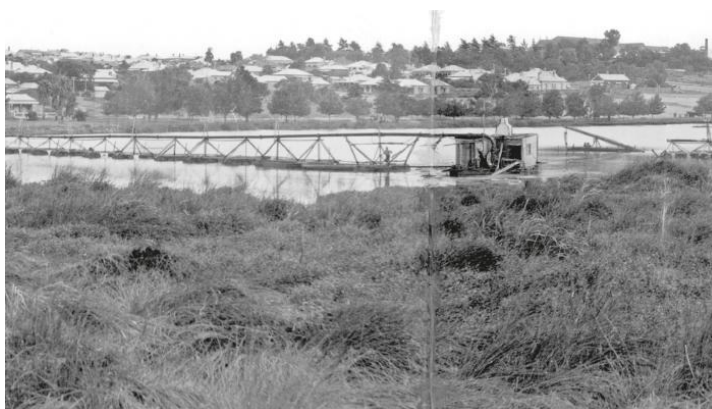
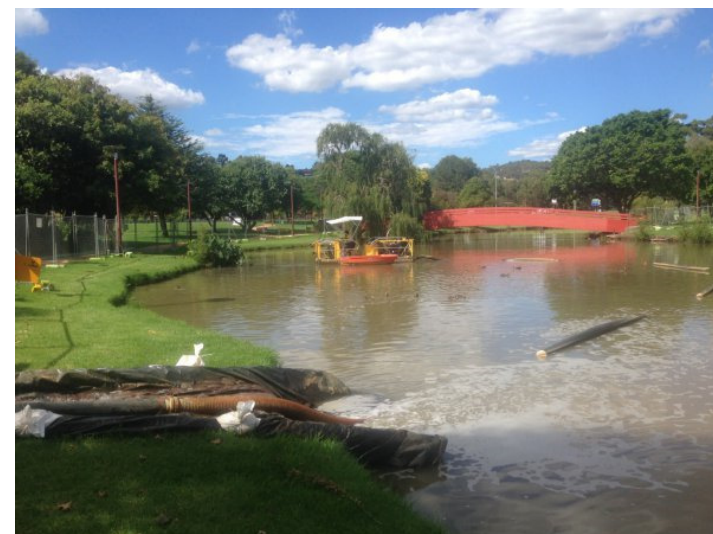
Modification/design

- Reshaping
- Revegetation
- Dredging – not a new idea:
 - Lake Monger c1934
 - Lake Minnawarra 2018
