Aim

- 1.To assess the effectiveness of using a solar powered pump in conjunction with a traditionally designed nutrient stripping basin to improve the water quality of Yangebup Lake while at the same time enhancing the habitat value of a degraded site
- 2. Optimising reduction of N and P in the natural system.

Solar Powered Nutrient Stripping Basin

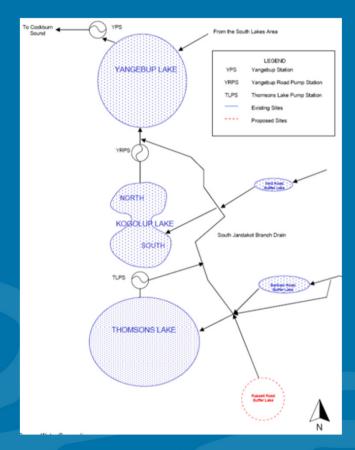
Fig 1. Schematic diagram South Jandakot Drainage Scheme

- Part of the eastern chain of the Beeliar Wetlands
- 82 hectares of open water
- Approx. 4 metres deep
- Part of South Jandakot Drainage Scheme

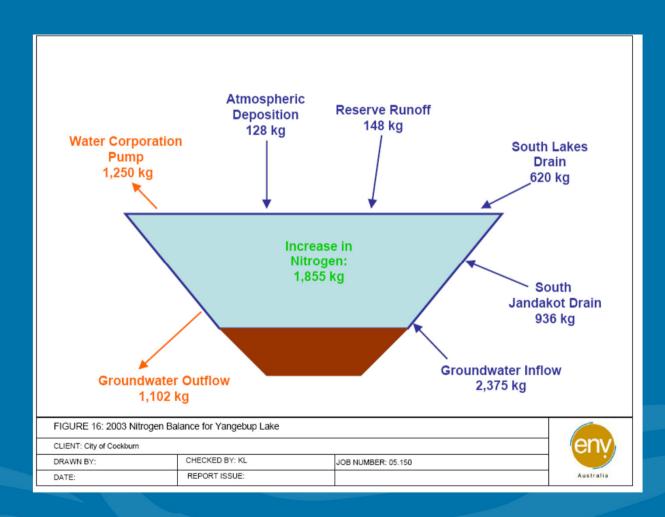
Nitrogen Balance 2003

- Arsenic contained within sediment (ENV 2003)
- Hypertrophic wetland
- Phosphorus is limiting nutrient to algal growth.
- Two largest additions of nutrients to the lake are from groundwater and storm water drains.
- Higher concentrations of nutrients in incoming surface water and reduced pumping to ocean have lead to net increase in nutrients leading to algae blooms and high numbers of nuisance midge.
- Management responses needed to address issues (midge)

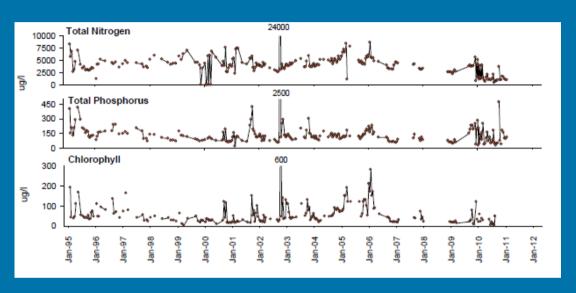
Source: Wyse and Lund 2012

Since 2009 Total N and P values have been trending down indicating that efforts focused on reducing nutrients have had a positive impact. Midge larvae densities and adult swarms have also been decreasing.

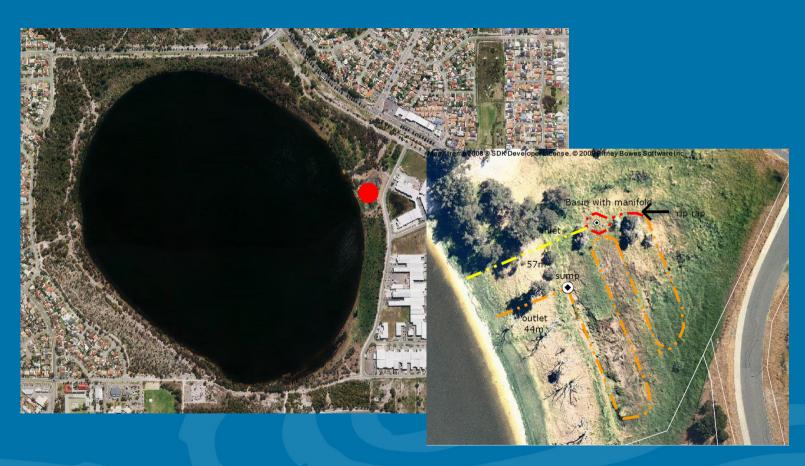
- Allows us to treat water already in the wetland.
- Additional vegetation to strip nutrients, provide shade and habitat & vegetation provides barrier for midge.
- Using solar power minimises ongoing costs.

8 x 170watt solar panels on 5m pole

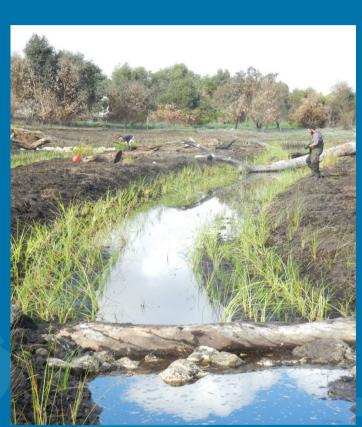
- Autumn 2015 Macroinvertebrate sampling and water quality analysis
- Weed control to remove Kikuyu
- Excavation of site -10,000 cubic metres of soil and organic material brought into site
- Logs and riffles placed
- 19,000 sedges, trees and shrubs installed
- 3 community planting events
- Funding received from State NRM Office Community Grants Program (\$26,000)
- Installation of footing, pole and solar array
- Installation of submersible pump
