Education and Behaviour Change Approaches – Better Practice for Waste Management Pilot Study

WALGA Waste Sorted

Prepared for WALGA

Project Number: TW20162

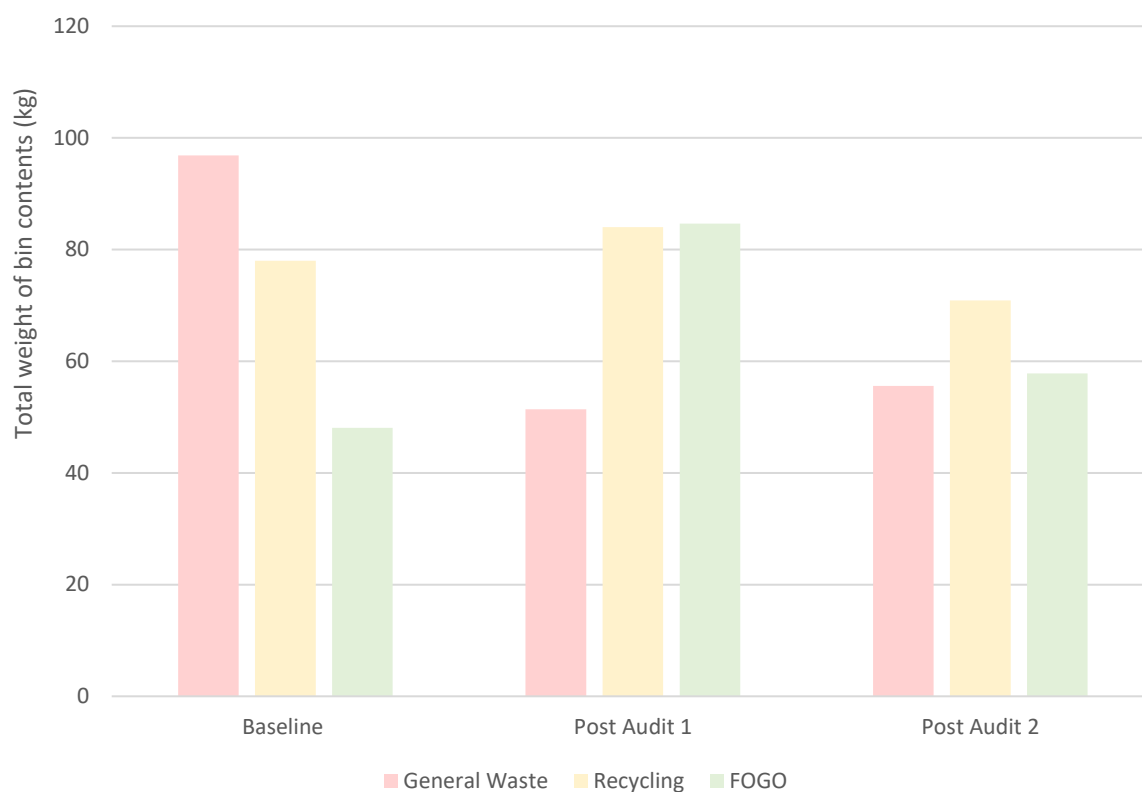
Figure 3: Total Weight of Bin Contents – Information Leaflets

Recycling bin weight was lowest during Baseline (77.99kg) and increased following approach implementation (84.02kg at Post Audit 1), however declined again at Post Audit 2 (70.89kg)

FOGO followed a similar trend to the recycling which was lowest at the Baseline (48.05kg) and increased following the approach implementation (84.02kg at Post Audit 1) and declined again at Post Audit 2 (57.83kg).

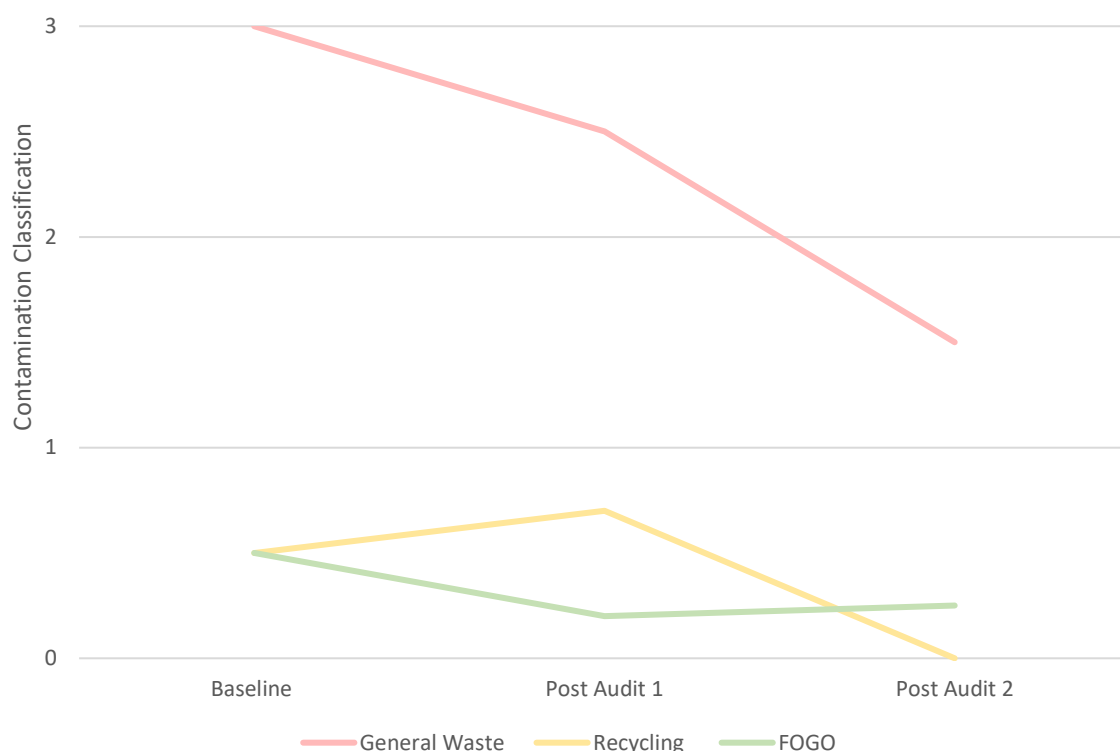
Figure 4: Average Contamination Trend – Information Leaflets

General waste had the highest average contamination at the Baseline Audit and reduced following the approach implementation. A similar trend was observed for the recycling and FOGO streams, refer Figure 4.

The trend indicated that following the approach implementation, average contamination rates decreased. General waste contamination decreased from 3 to 1.5, recycling from 0.5 to 0 and FOGO from 0.5 to 0.25.

Table 3-2 shows the average contamination classification across all three waste streams observed at the Baseline and Post Implementation Audits and the trend is shown in Figure 4.

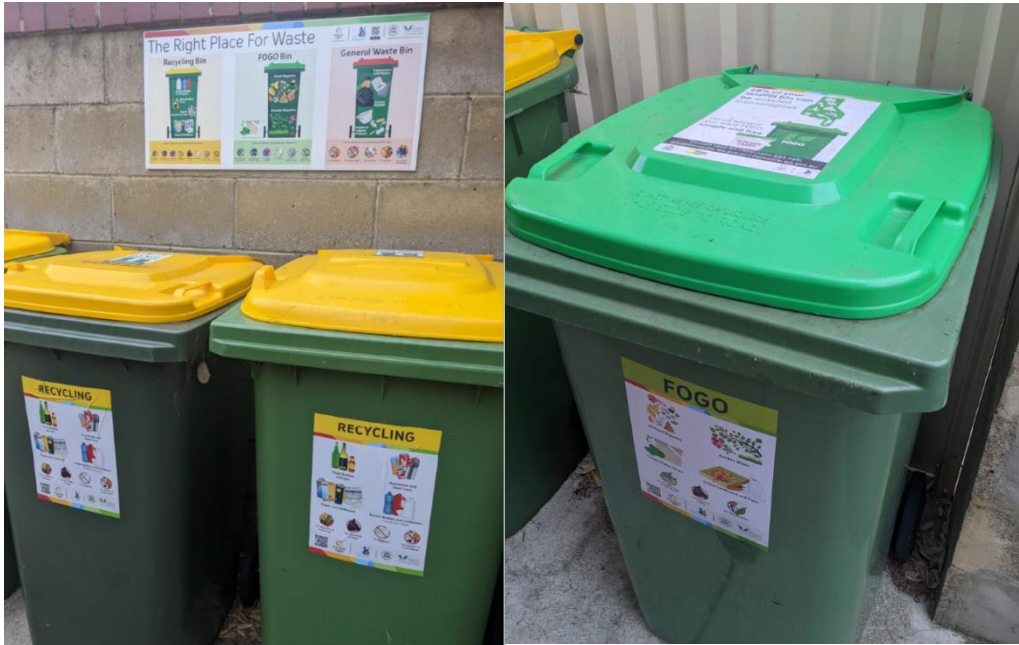
Figure 5: Bin Signage and Stickers Delivered

Therefore, the City of Fremantle introduced bin storage area signage and stickers on the bins to the second selected MDD in this Study, refer Figure 5. This included large signs above the bins displaying what can and cannot be placed into each waste stream (refer Figure 6) and stickers on the front of the individual bins (refer Figure 7). This is included as an information-based approach through review of the Better Practice Guidelines.

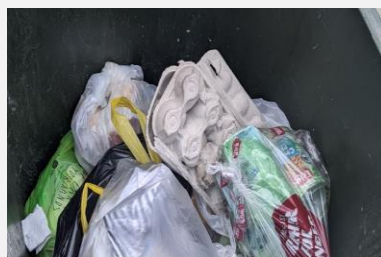
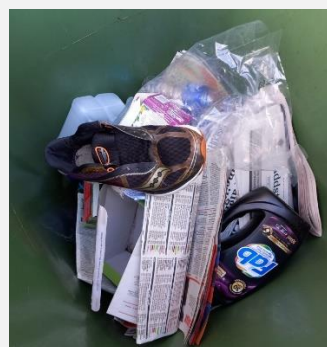
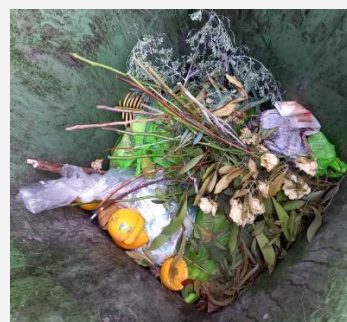
General waste had the highest average contamination at the Baseline Audit and reduced following the approach implementation. A similar trend was observed for the recycling and FOGO streams.

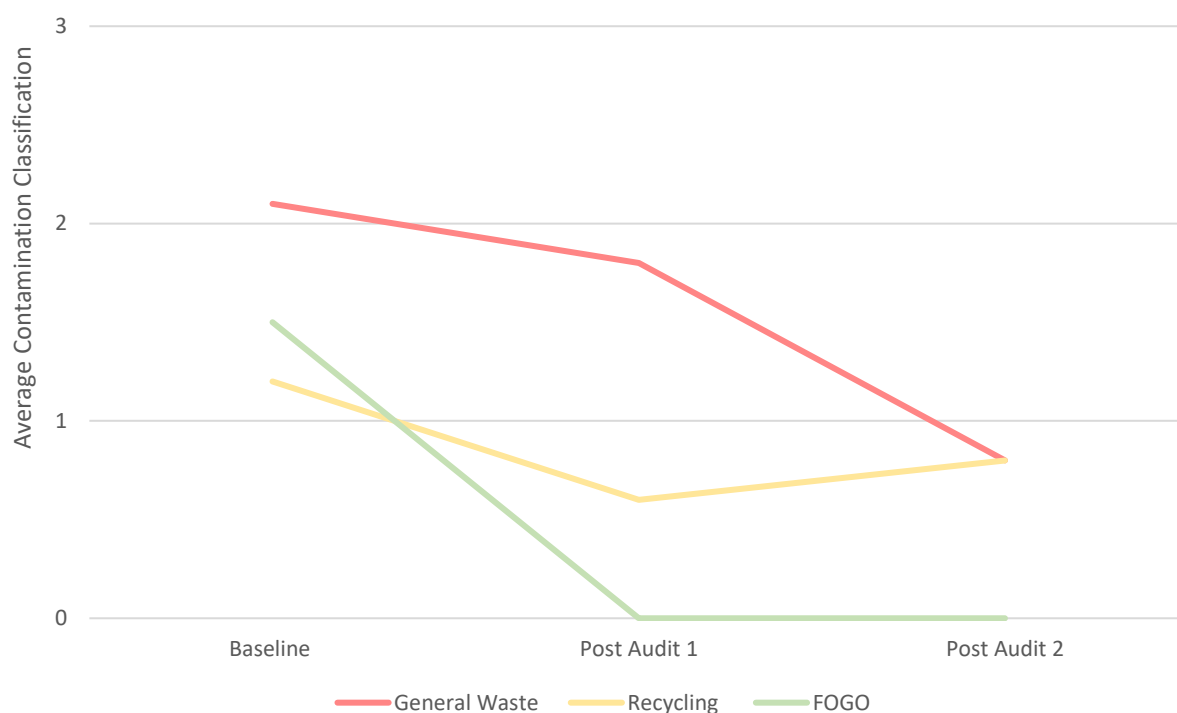
Figure 9: Average Contamination – Signage and Stickers

The trend indicated that following the approach implementation, average contamination rates decreased. During the audits, general waste contamination decreased from 2.1 to 0.8, recycling from 1.2 to 0.8 and FOGO from 1.5 to 0.

Table 3-3 shows the average contamination classification across all three waste streams observed at the Baseline and Post Implementation Audits and the trend is shown in Figure 9.

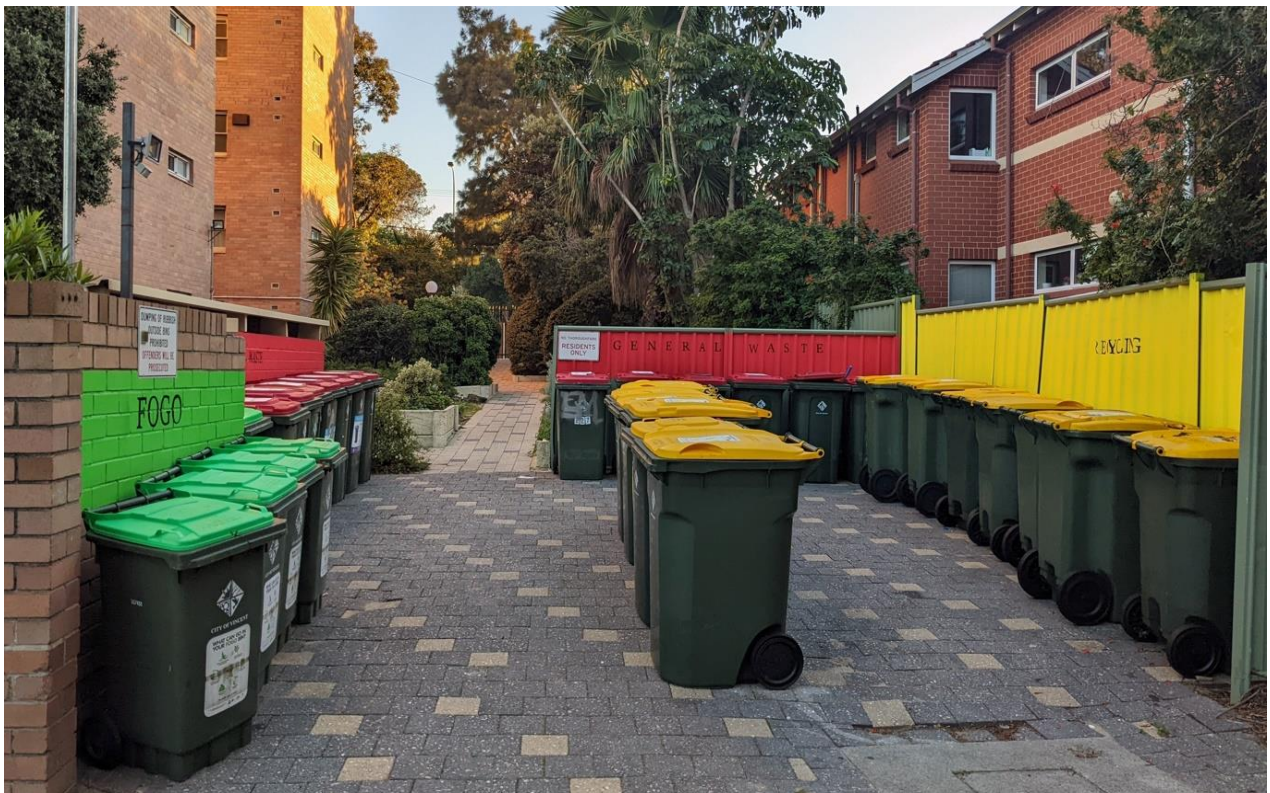
Figure 11: MDD Bin Storage Area – Post-Approach Implementation

Bins were then repositioned to ensure the general waste stream bins were more accessible (closest to the residential accessways) to deter residents from contaminating the recycling & FOGO bins as they were less accessible.

Storing waste streams against colour coded walls can help re-enforce correct source separation and enable easy identification of what materials should and shouldn't be placed into each bin. Colour markings can also ensure bins are always returned to the same location to maintain consistency and bin storage area amenity.

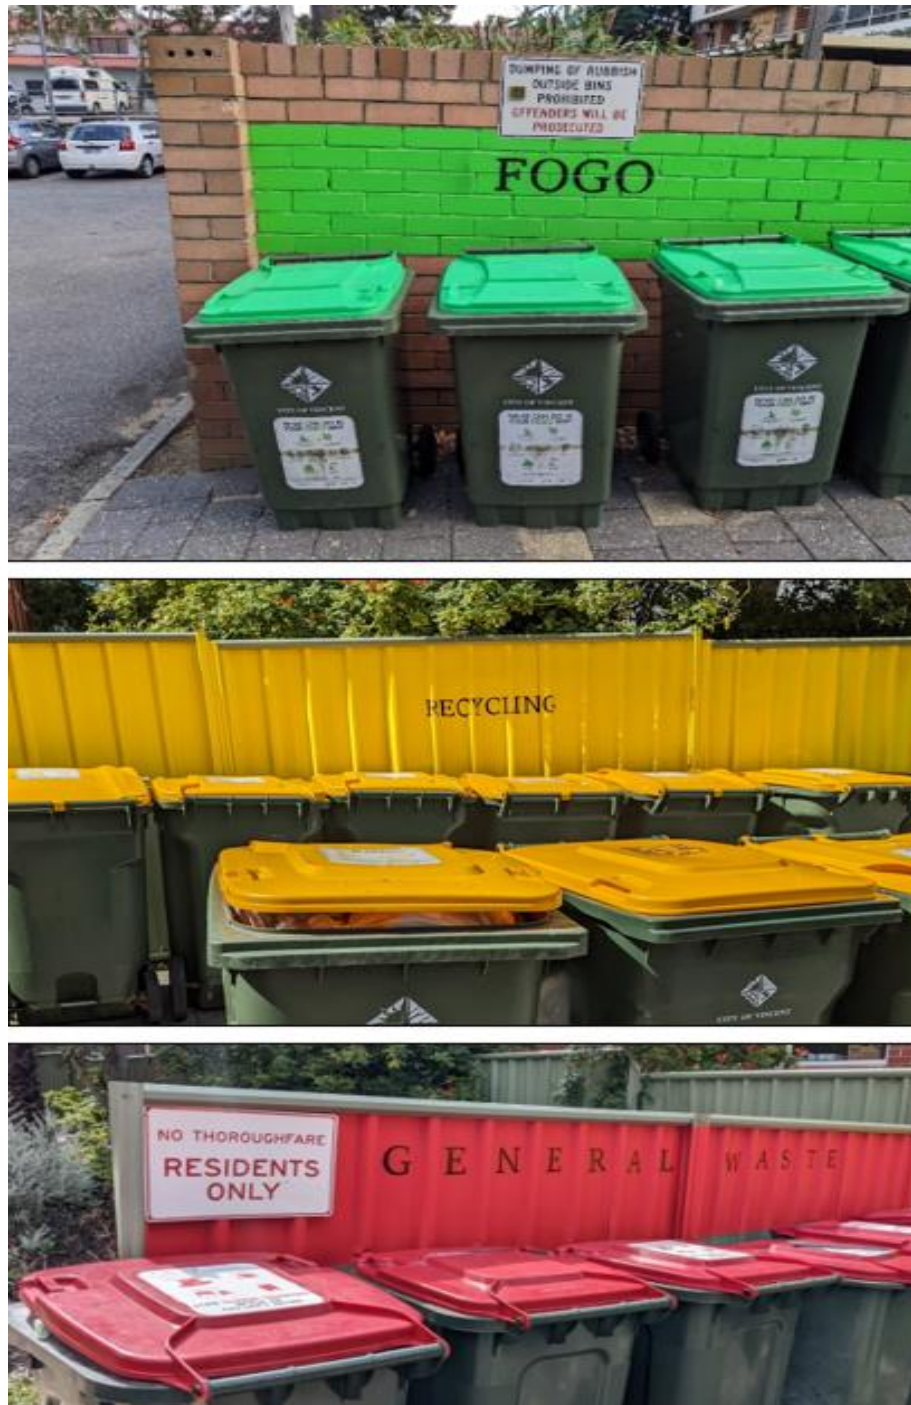
Figure 12: Visual Colour Approach Implementation

The City chose an information based approach and following the Baseline audit, the City of Vincent transformed the MDD bin storage area using bright colours on the walls (behind bins) and arranging the bins into designated areas based on the individual waste streams (refer Figure 10, Figure 11 and Figure 12). The floor underneath the bins were also painted/marked out so that residents know where to place the bins in the correct spot.

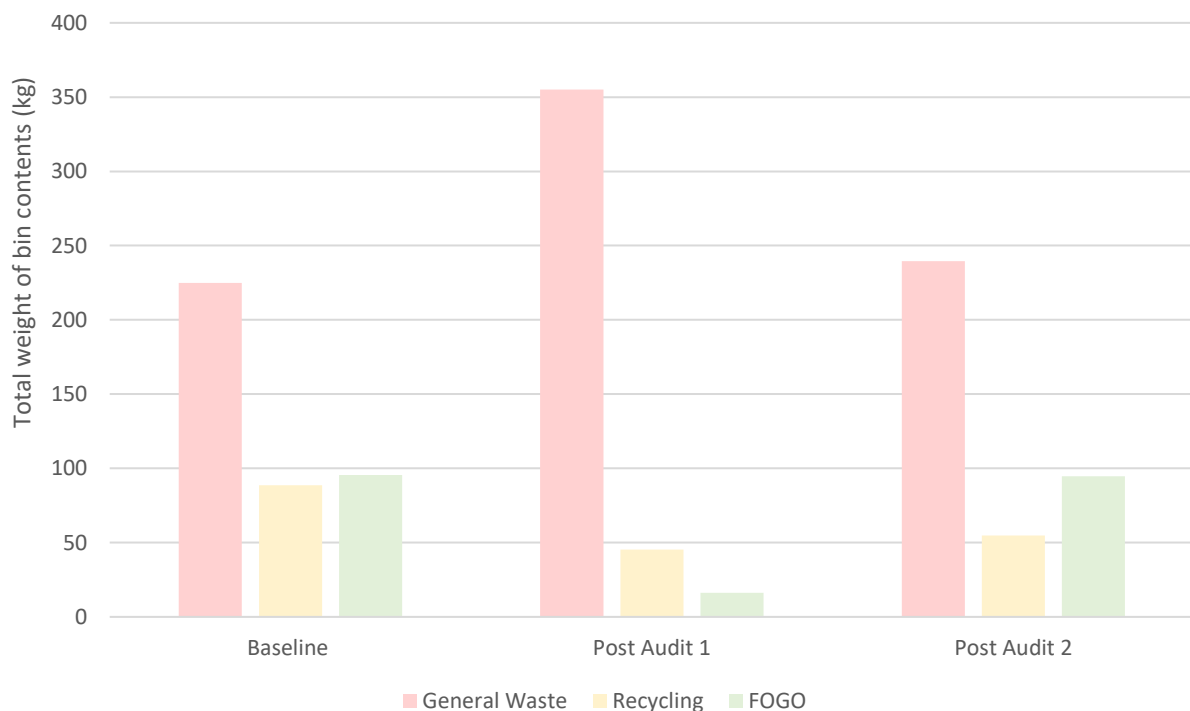
Figure 13: Total Weight of Bin Contents – Visual Colour and Bin Arrangement

The recycling total weight at the Baseline was 88.54kg and this generally decreased after the approach implementation (54.78kg at Post Audit 2).

The FOGO total weight at the Baseline was 95.62kg and this decreased slightly after the approach implementation (94.71kg at Post Audit 2).

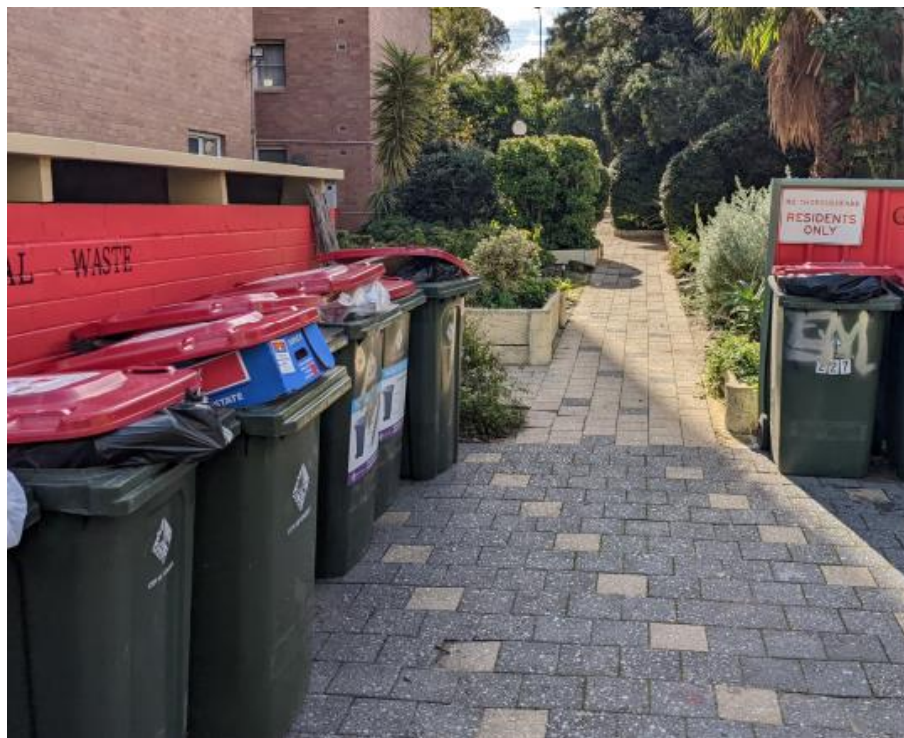
Figure 15: Full general waste bins located near the residential accessways

- The audit results revealed high levels of contamination across all waste streams, along with high total weights of general waste, suggesting poor waste minimisation and source separation behaviours at the MDD prior to the education approach being implemented.
- The visual audits revealed success in the re positioning of bins to reduce contamination by ensuring the general waste stream is more accessible (closest to the residential accessway) to deter residents from contaminating the recycling & FOGO bins. This could be observed through the greater volumes of waste in the general waste bins which were positioned close to the residential accessway as part of the approach, and lower volumes in the recycling bins placed further away, refer Figure 15.

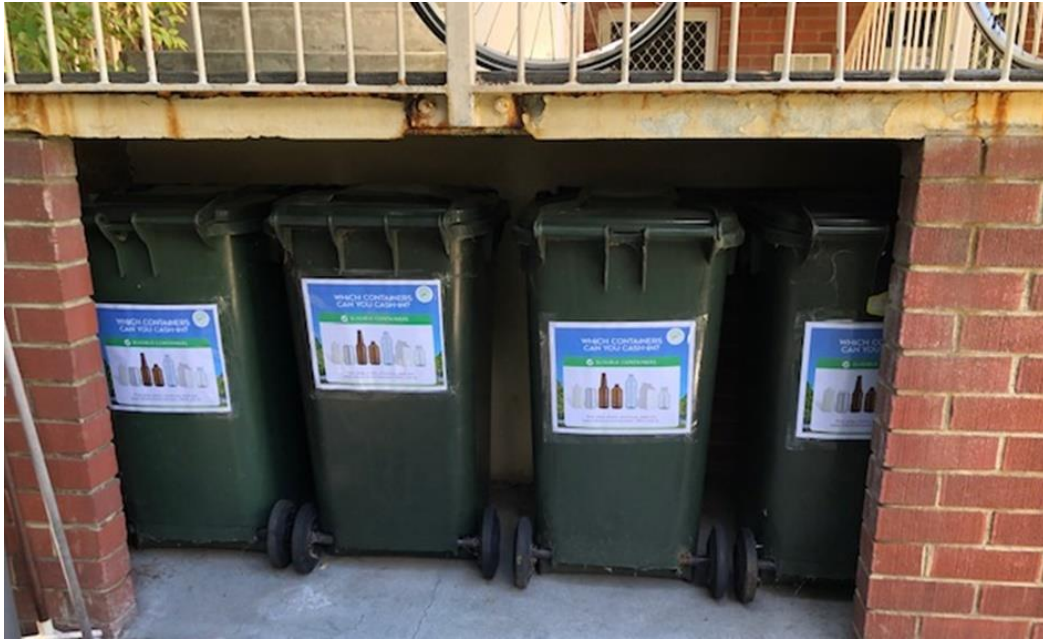
Figure 16: Bins Distributed for CDS Eligible Materials

Two staff members from the Town provided a one-hour engagement session with the willing residents of the MDD. A summary of the materials and resources provided at the workshop and resident feedback received is shown in Table 3-5. As part of the engagement, dedicated bins for Container Deposit Scheme (CDS) eligible items were provided to residents, refer Figure 16.

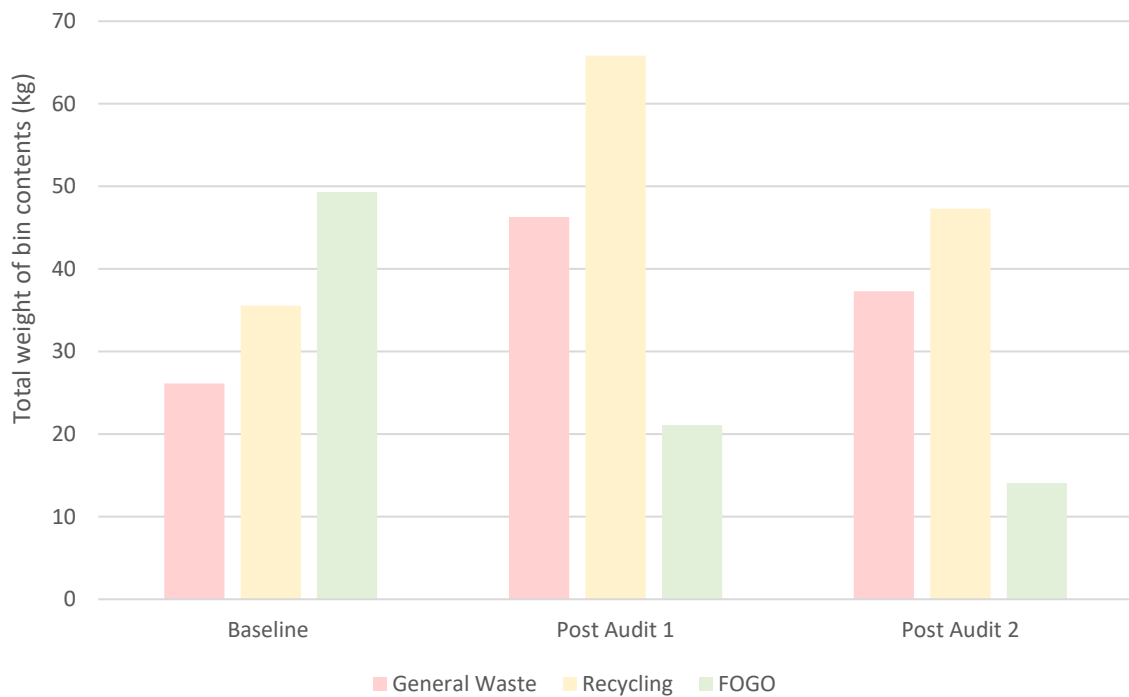
Figure 17: Total Weight of Bin Contents – Engagement Workshop

The recycling weight was typically the heaviest (highest at 65.82kg at Post Audit 1) and the weight generally increased following the Baseline audit.

The FOGO stream was highest during the Baseline audit (49.31kg) and decreased following approach implementation (14.06kg at Post Audit 2).

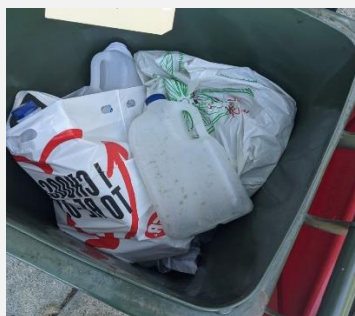
The highest contamination classification was found in the general waste stream (2.2 at Post Audit 1) and the lowest contamination was found in the recycling stream (0.2 at Post Audit 2).

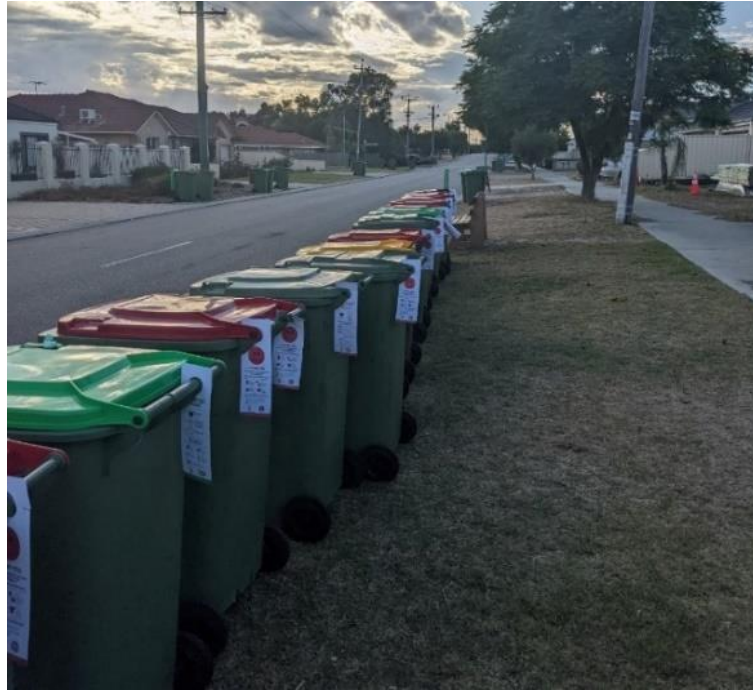
Figure 19: Bayswater Bin Tagging Approach Implementation

Therefore, the City chose an engagement based approach to conduct individual bin inspections and tagging at the selected MDD, refer Figure 19.

The City completed five weeks of bin tagging at the MDD which reflects a standard round of their household bin tagging program.

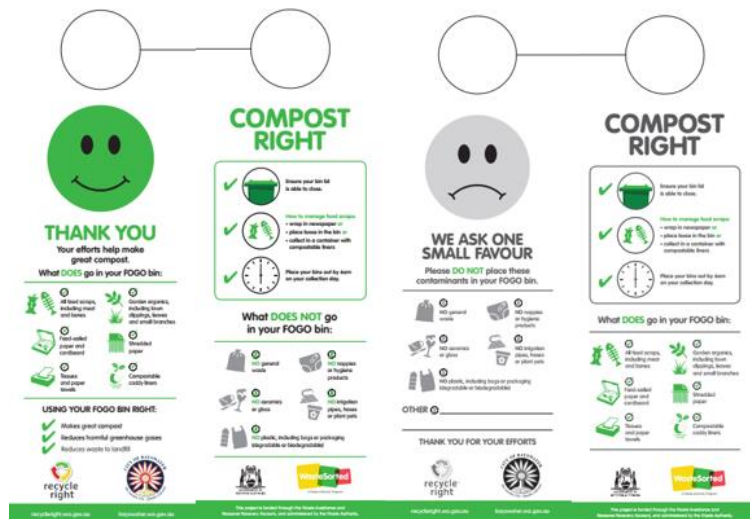
Figure 20: Example Bin Tags (FOGO Waste Stream)

The tags include a ‘happy’ or ‘sad’ face to indicate whether the bins have the correct materials inside or whether there are some incorrect items (contamination), refer Figure 20. There is also the opportunity to provide specific written feedback on the tags to help make certain issues clearer.

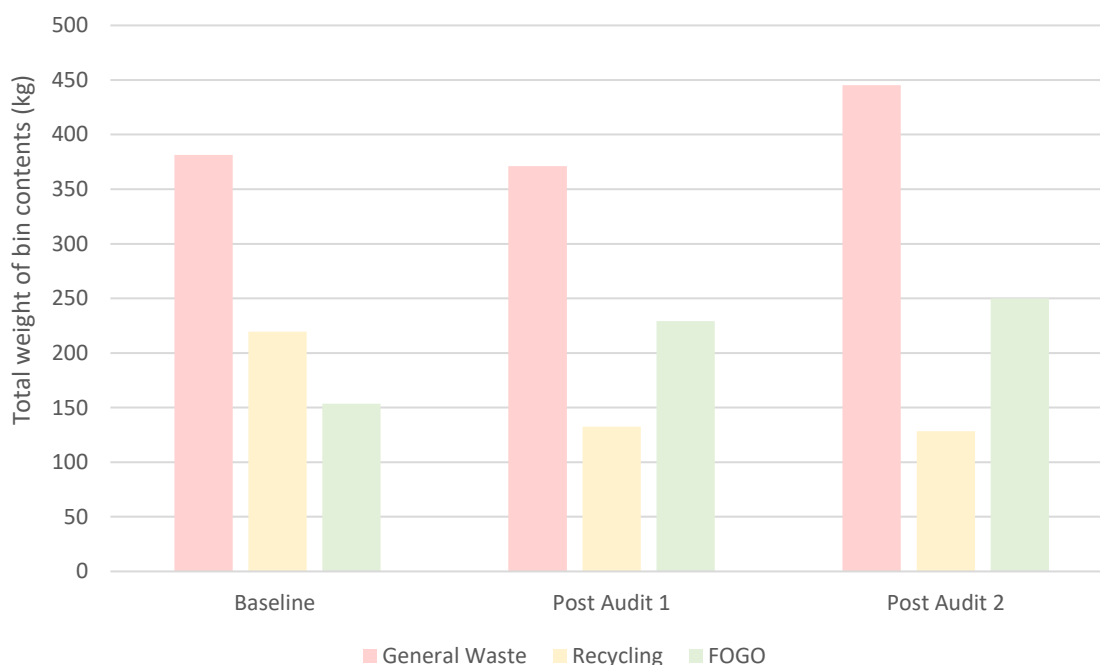
Figure 21: Total Weight of Bin Contents – Bin Inspections/Tagging

Recycling weight was highest during Baseline (219.43kg) and decreased following approach implementation (128.38kg at Post Audit 2).

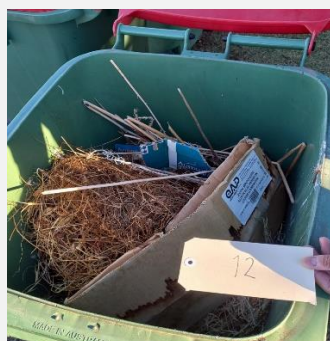
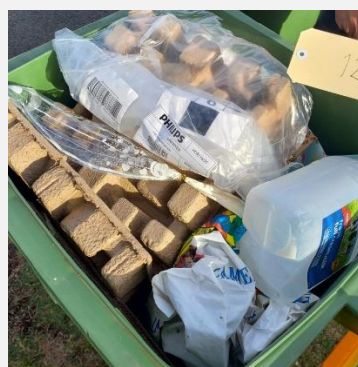
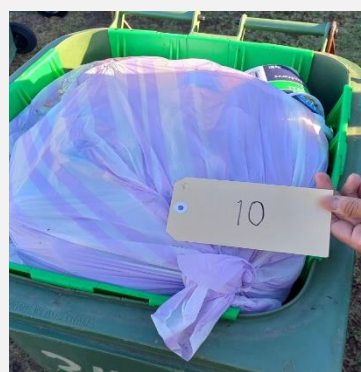
General waste had the highest average contamination at the Baseline audit and reduced following the approach implementation. A similar trend was observed for the recycling and FOGO streams.

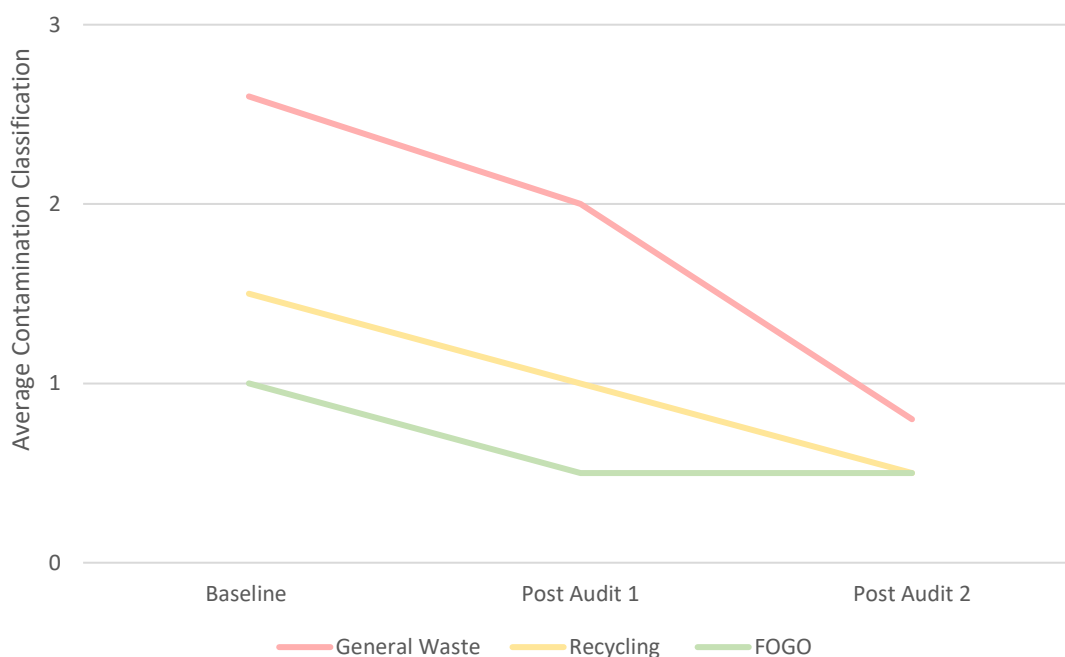
Figure 22: Average Contamination – Bin Inspections/Tagging

The trend indicated that following the approach implementation, average contamination rates decreased. General waste contamination decreased from 2.6 to 0.8, recycling from 1.5 to 0.5 and FOGO from 1 to 0.5.

Table 3-7 shows the average contamination classification across all three waste streams observed at the Baseline and Post Implementation Audits and the trend is shown in Figure 22.

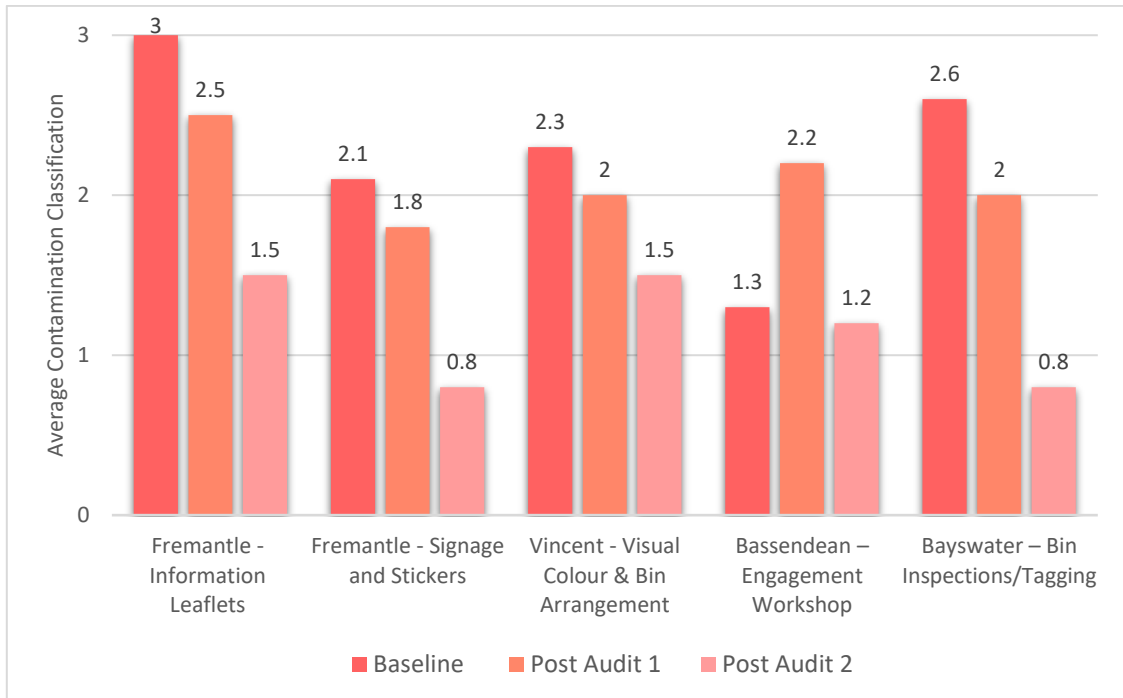
Figure 23: General Waste Average Contamination per Approach

For the general waste stream, overall, diversion from landfill increased for all approaches following implementation with the exception of the engagement workshop, which initially increased at Post Audit 1 and then decreased to initial Baseline levels, refer Figure 23.

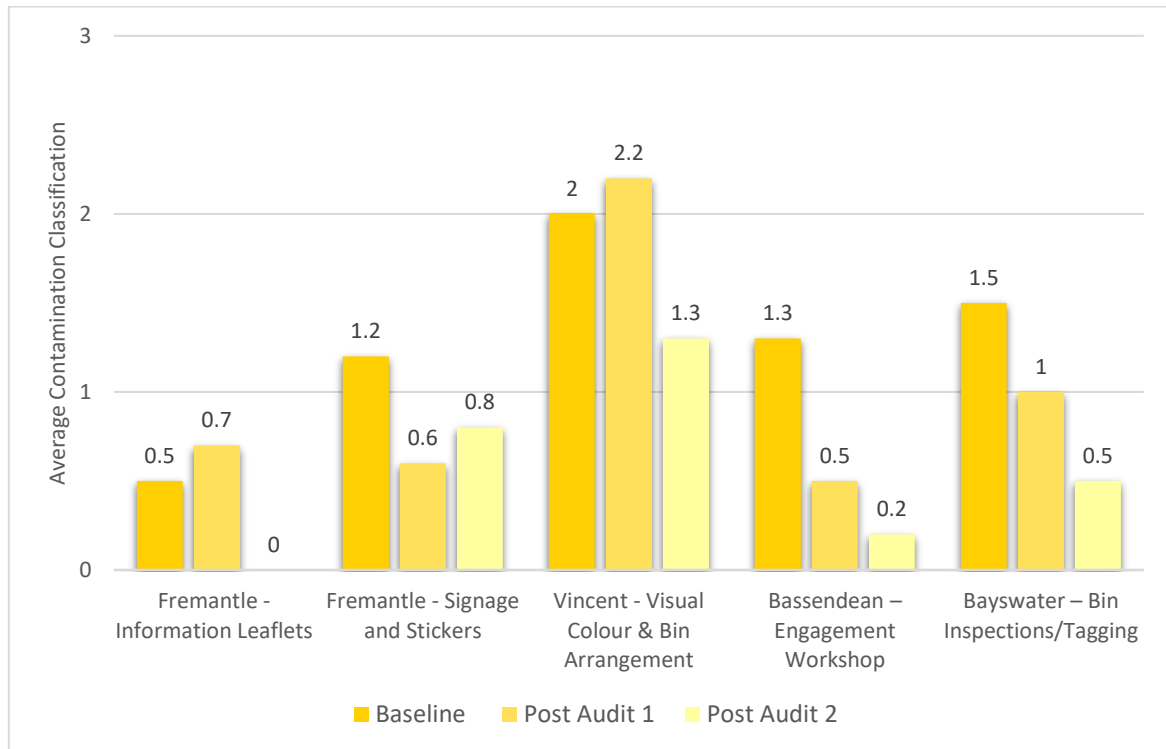
Figure 24: Recycling Average Contamination per Approach

For the recycling stream, contamination decreased for all approaches from initial Baseline results. Information leaflets and visual colour and bin arrangement approaches observed a slight increase in contamination at Post Audit 1, but then decreased at Post Audit 2, refer Figure 24. It is observed that the information leaflets, engagement workshop and bin inspection approaches were most effective on the recycling stream contamination.

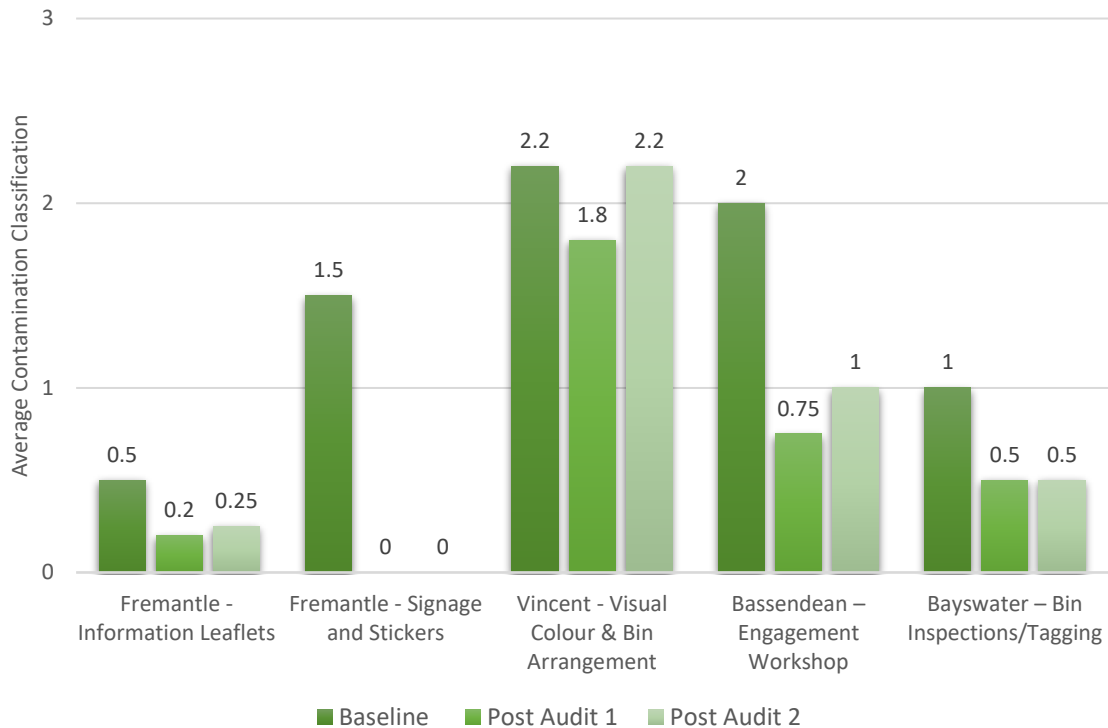
Figure 25: FOGO Average Contamination per Approach

For the FOGO stream, contamination decreased for all approaches from initial Baseline results, with the exception of the visual colour and bin arrangement approach which increased to initial Baseline results, refer Figure 25. It is observed that the signage and stickers approach was most effective on the FOGO waste stream contamination.
